## **Performance of Fire Adapted 50 Fuel Treatment Units During the Caldor Fire**

**Prepared by El Dorado Resource Conservation District**

**October 2021**

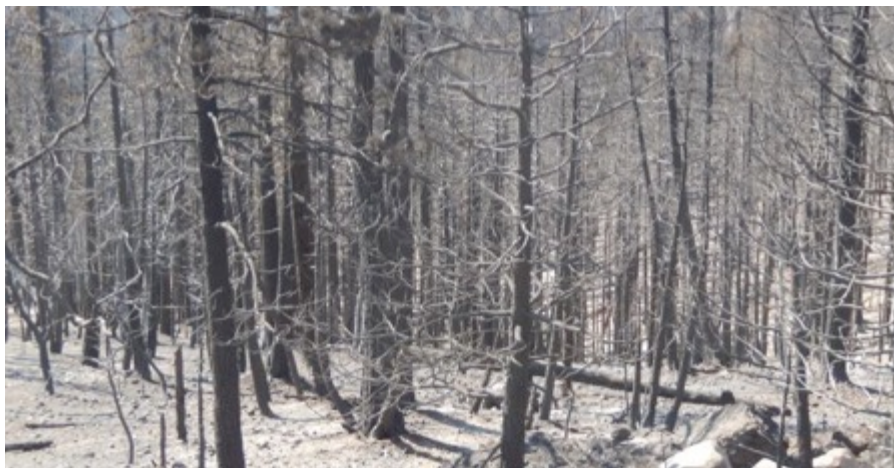
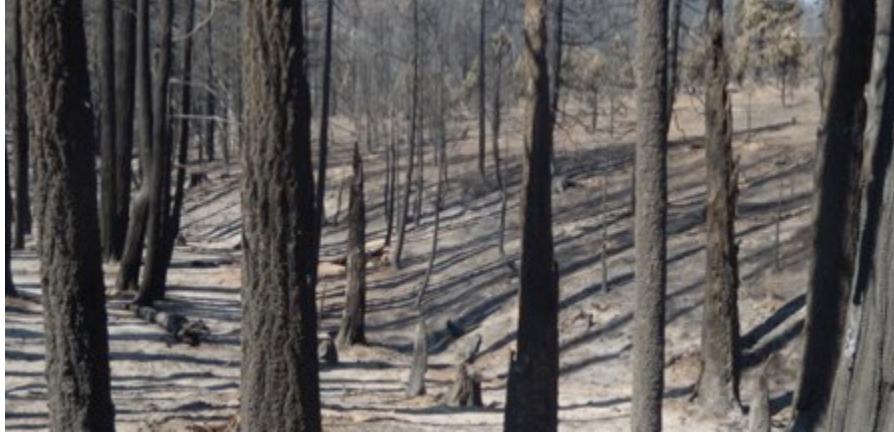
Extensive tree mortality and presence of white ash are indicative of how intense the fire was in areas that experienced high severity fire. In dense thickets of small and pole sized trees there were generally no surviving trees. In stands with larger trees, some may have survived the immediate effects of the fire but because of their post-fire susceptibility to bark beetle attack, they may ultimately die. Although no estimates of tree mortality currently exist, maps of soil burn severity prepared by the Burned Area Emergency Response Team indicate that approximately 13 percent of the burn experienced high severity fire. The team defines high severity fire as complete elimination of all surface fuels and presence of bare ground or several inches of ash susceptible to erosion and water quality impacts during upcoming precipitation events. Our observations in the burned area suggest that severity as indicated by tree mortality encompasses a much greater area. For example, on one surveyed road, North South Road, over 15 miles of road traversed an area of total tree mortality.

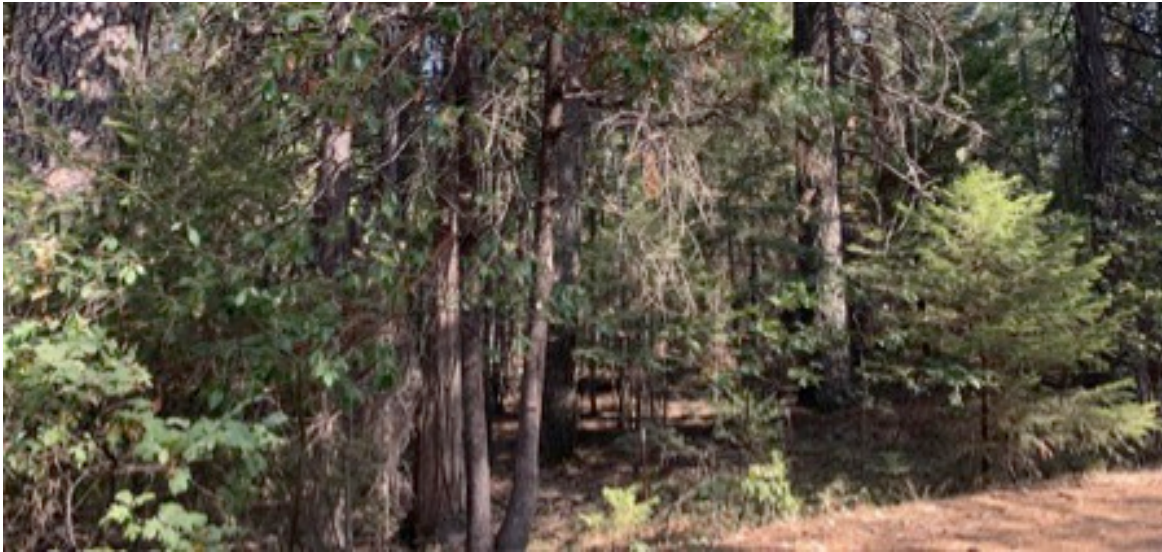
The majority of the unmanaged forest in the general area of Sly Park Recreation Area is overstocked with dense understories of small shade tolerant trees and shrubs (see following photograph). The condition reflects a recent history during which timber harvesting has been limited due to a variety of economic, social and regulatory constraints.

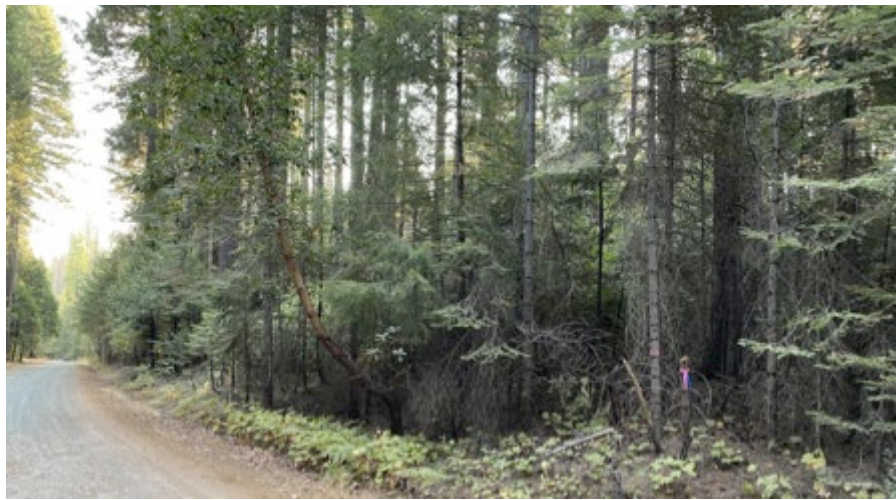
to a height of 10 feet. Pre-treatment conditions in one unit are shown below (Photograph #115, see Figure 2 for photograph locations).

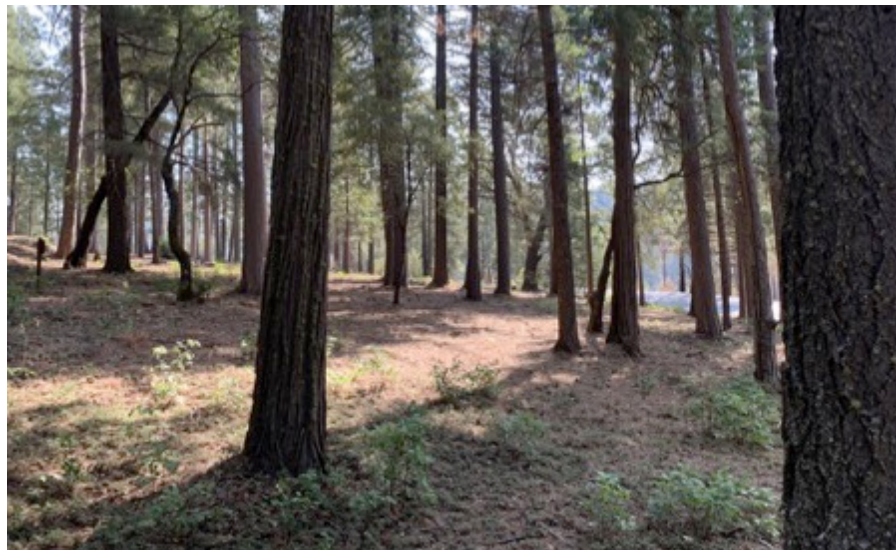
Conditions immediately after treatment in a similar unit are shown in the following photograph (not geo-referenced).

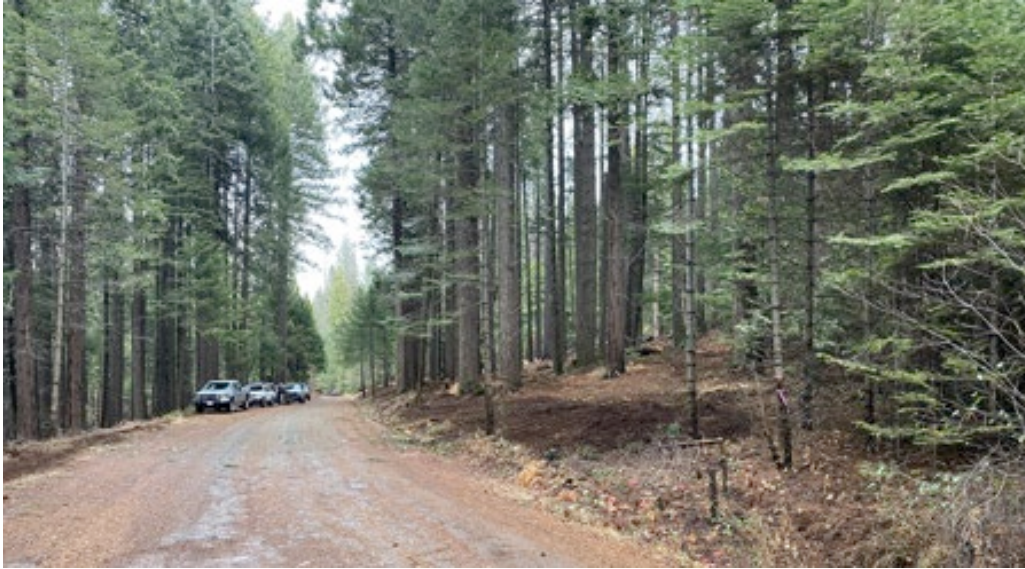
Subsequent to the Phase 1 – SNC treatment, the units were logged to further enhance stand resiliency. The logging prescription was to reduce basal area to 85-125 square feet/acre and to separate crowns. Post-logging conditions in the unit shown in the first photograph above are illustrated in the following photograph (Photograph #115).

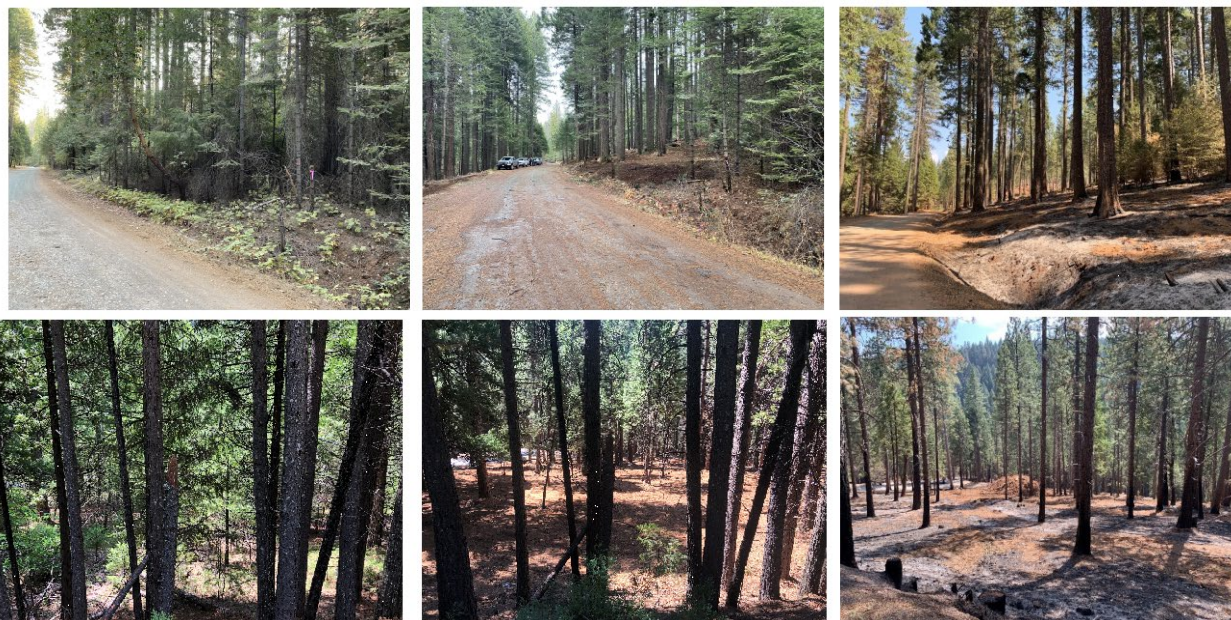
## Photographs #115 and #111

**#111.** 38°42.942' N, 120°34.020' W  
3 photos – Pre-treatment, post treatment, post logging and fire- SNC

**#115.** 38°42.935' N, 120°33.865' W  
3 photos – Pre-treatment, post treatment, post logging and fire - SNC

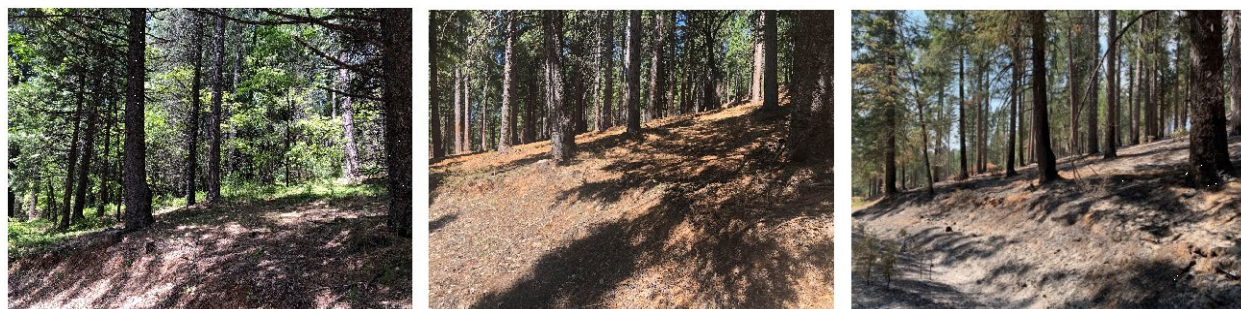
## Photographs #112

**#112.** 38°42.908' N, 120°33.942' W  
3 photos – Pre-treatment, post treatment, post logging and fire - SNC

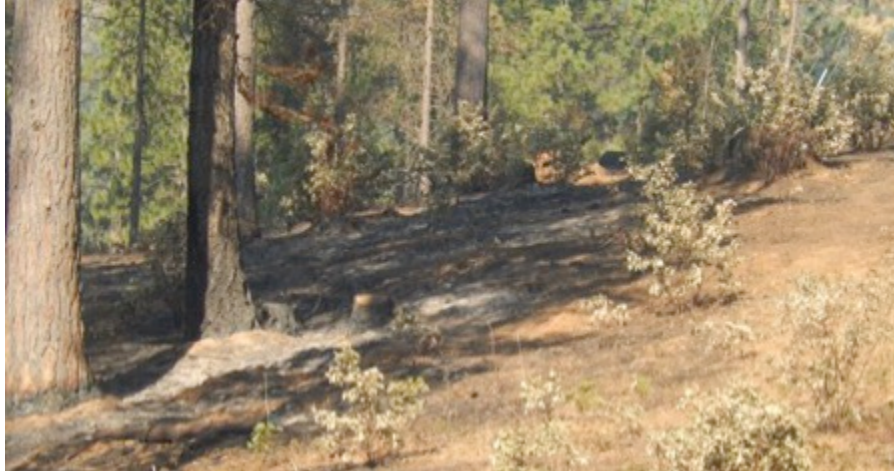
In general, all surface fuels were consumed within the units. There were exceptions, however, as illustrated in the following photograph showing shrubs that withstood the backfiring (not geo-referenced).

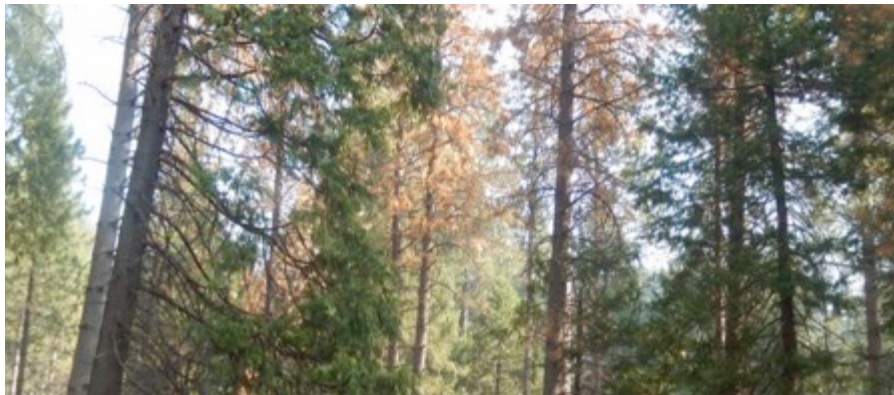
Also, it is notable that backfiring did not ignite standing dead trees that had been killed by bark beetles (see following photograph, not geo-referenced).

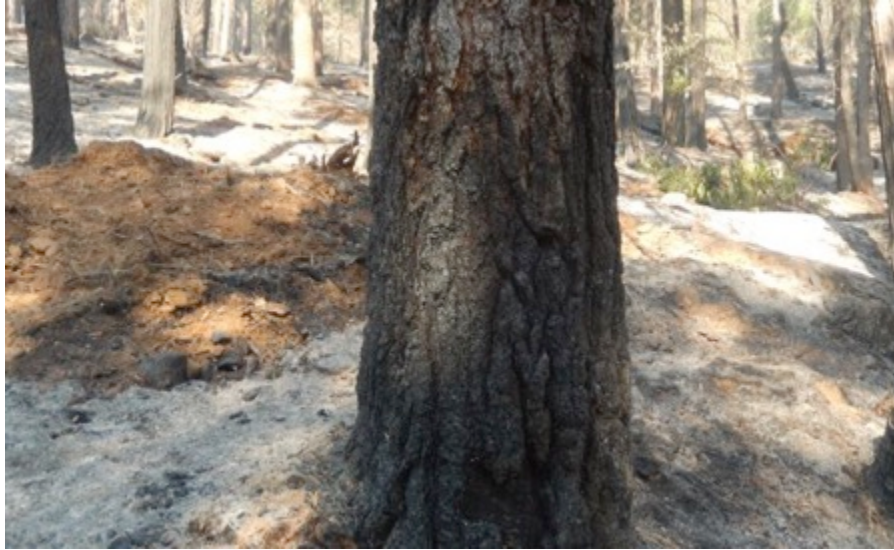
Scorch height on trees was between two and four feet, uncommonly more and depth of scorch appeared superficial, suggesting low likelihood of damage to the cambium. Scorch height indicated that flame length was generally less than four feet. A few trees experienced severe scorching, shown in the following photograph and these could be susceptible to future attack by red turpentine beetle. Observations at the Angora Fire on Tahoe Conservancy land indicated invasions in severely scorched trees by that beetle within weeks of the fire. Red turpentine beetle is not normally a cause of mortality in itself but its attack can make trees vulnerable to attack by other insects such as western pine beetle.

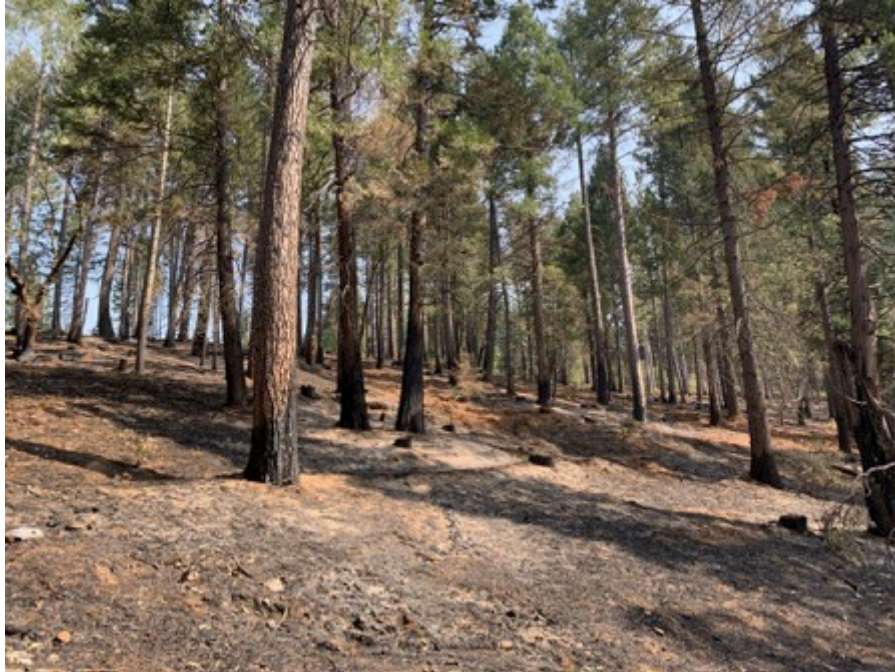
Photograph #1

Post treatments, post logging, post burn -SNC

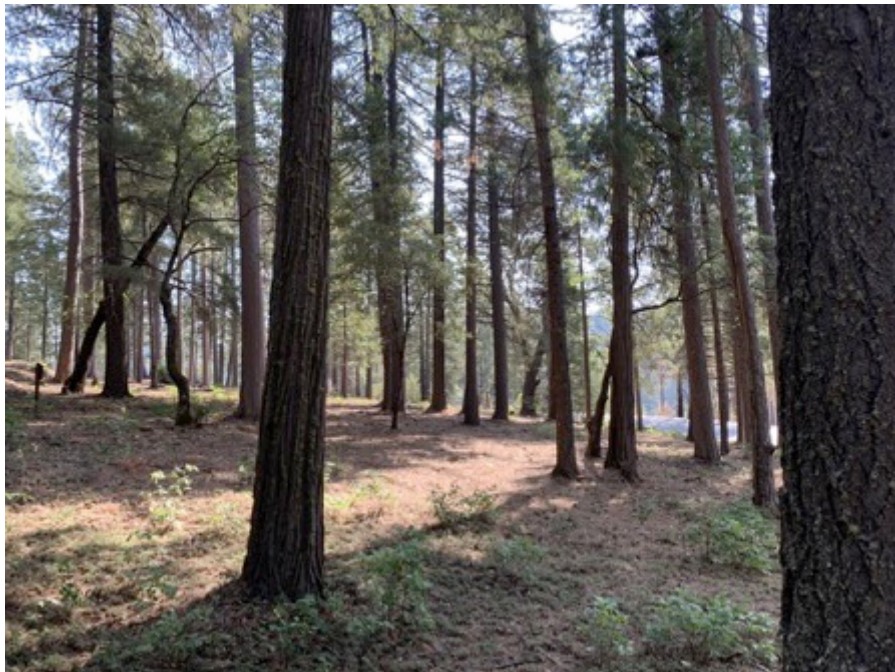
Photograph #4

Post treatments, post logging, post burn - SNC

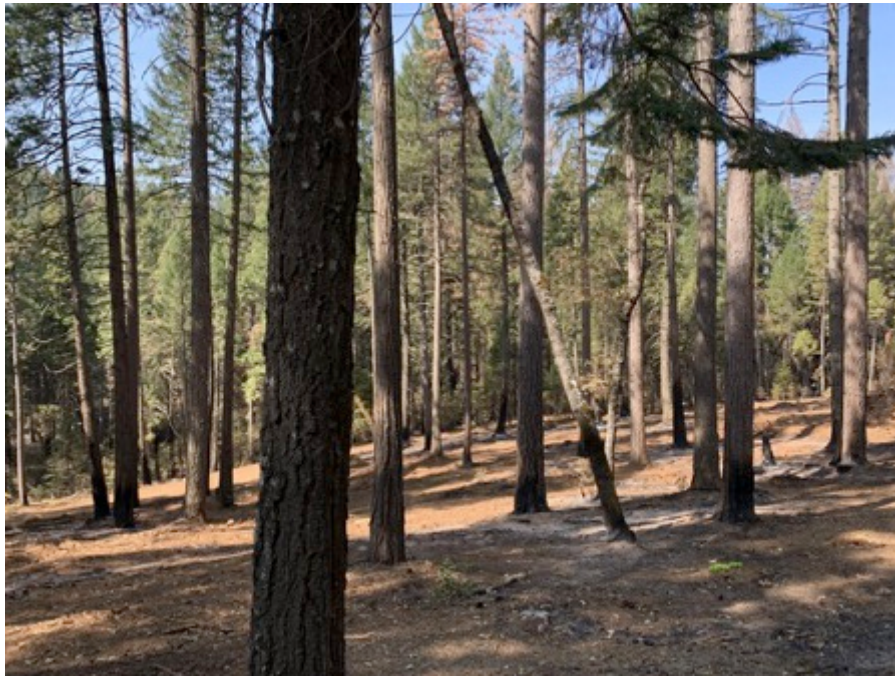
Photograph #5

Post treatments, post logging, post burn - SNC

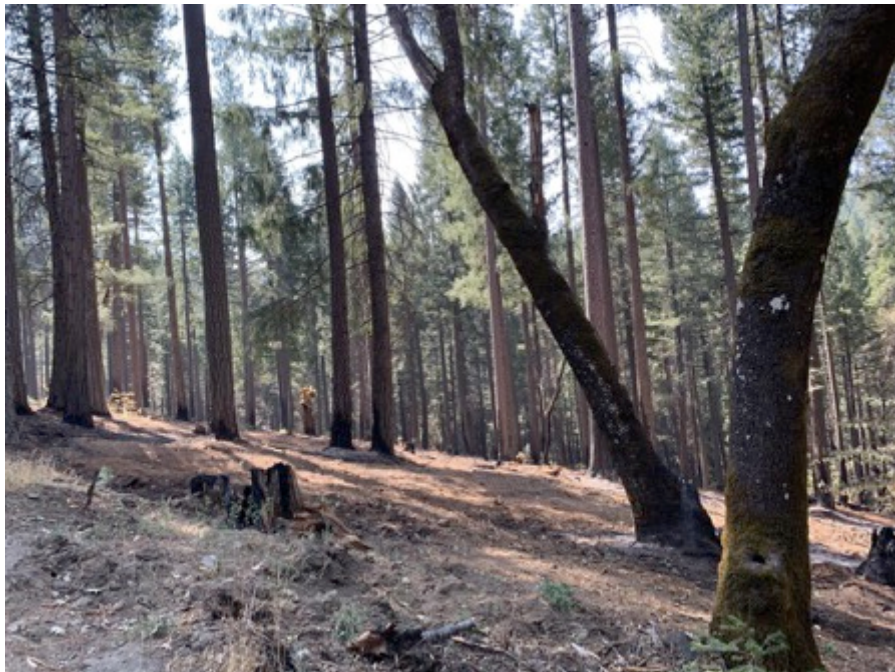
Photograph #6

Post treatments, post logging, post burn - SNC
